DEPARTMENT OF NATURAL RESOURCES Division of Oil, Gas & Mining

Inspection Report Minerals Regulatory Program

Mine Name:	United Stone	Permit number:	Unpermitted,
			Care State of the

Operator Name: United Stone and Design Inspection Date: June 28, 2006

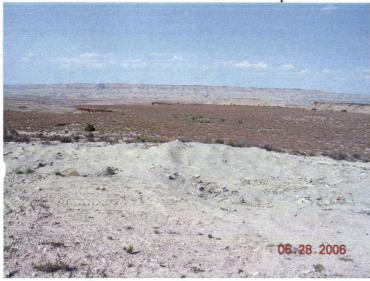
Photo 1. This is the first disturbance I discovered two years ago. It has not been reclaimed, but the operator has removed palletized stone that was being stored here.

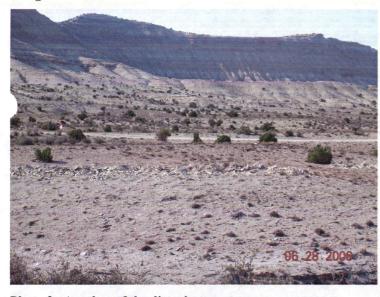
Photo 2. Another of the disturbances.

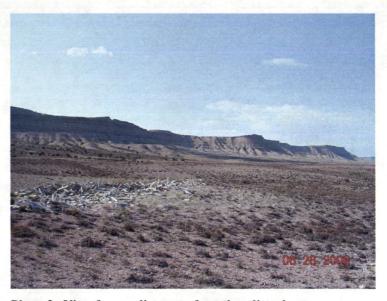
Photo 3. View from a distance of another disturbance.

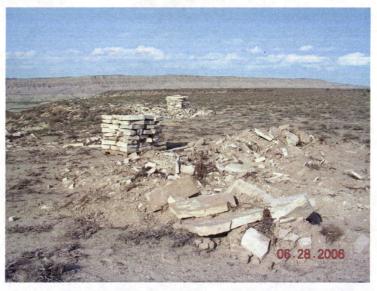
leading to the site shown in Photos 4 and 5, are more substantial. All of these roads would require some degree of reclamation. Some would probably come back on their own if further vehicle access was prohibited.

The site shown in Photo4 has been disturbed very recently.

Photo 4. This activity is very recent, probably within the past few days.

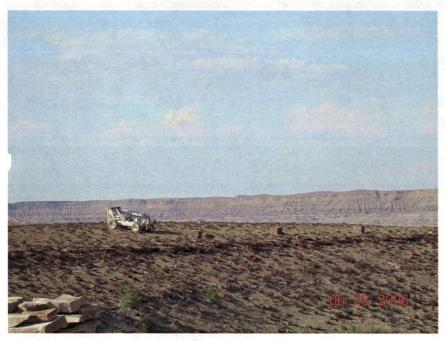
In addition to the areas where stone has been lifted from the ground with a forklift, the operator has done a lot of hand collecting in the area. This stone is loaded by hand on to pallets, then it is loaded on trucks using a forklift.

Photo 5. This shows the operator's forklift and pallets of stone typical of what the operator has collected by hand.

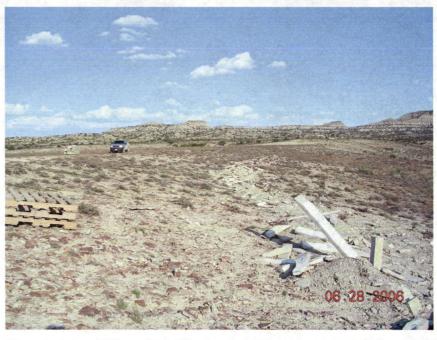
I am uncertain exactly how much disturbance the operator has created. This was my fifth trip to the area, and each time I have found disturbances I did not previously notice. Most of them are on the east side of Johnson Draw, but I have now found two on the west side. Each individual disturbance is relatively small, about 1/4-2/3 acre, which totals 2.38 acres for these disturbances (see attached map). There are at least five additional areas from which stone has been taken, and the total disturbance not including roads could be over five acres.

Photo 6. A newly-discovered disturbance on the west side of Johnson Draw.

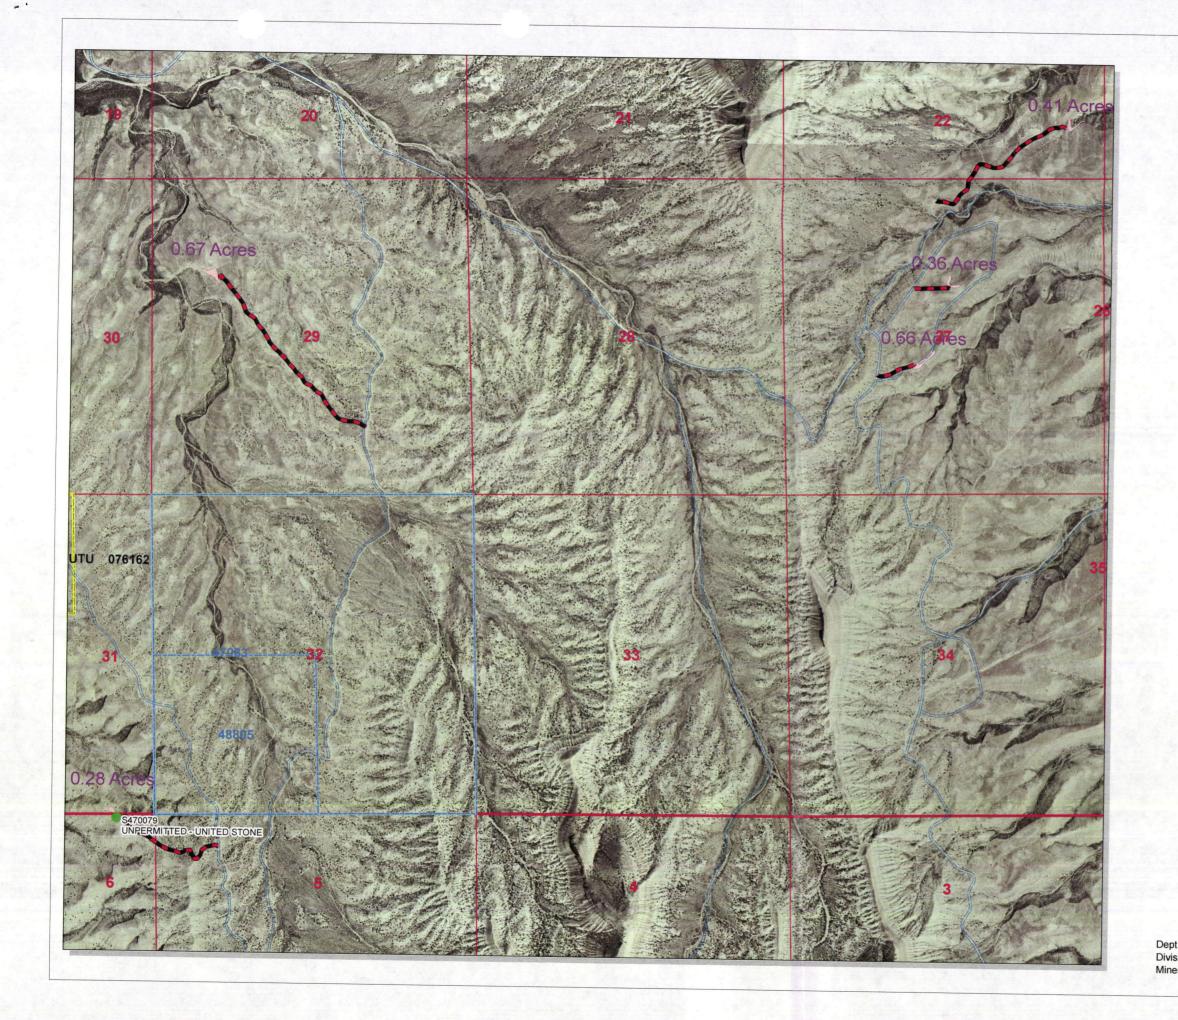
The roads shown on the map total 9983 feet or about 1.9 miles, and assuming an average width of 10 feet, disturbances from roads is 2.29 acres. The actual area disturbed by roads is greater than this figure.

The Notice needs to include a map showing the locations of all the areas the operator has disturbed. This is a very remote location, and the sites are scattered.
